OHIO RIVER BASIN  
CHERRY RUN, INDIANA COUNTY  
PENNSYLVANIA  
CHERRY RUN DAM

6 PHASE I INSPECTION REPORT  
NATIONAL DAM INSPECTION PROGRAM.

10 Bernard M. Mihalcin  
PREPARED BY

11 AUGUST 1979

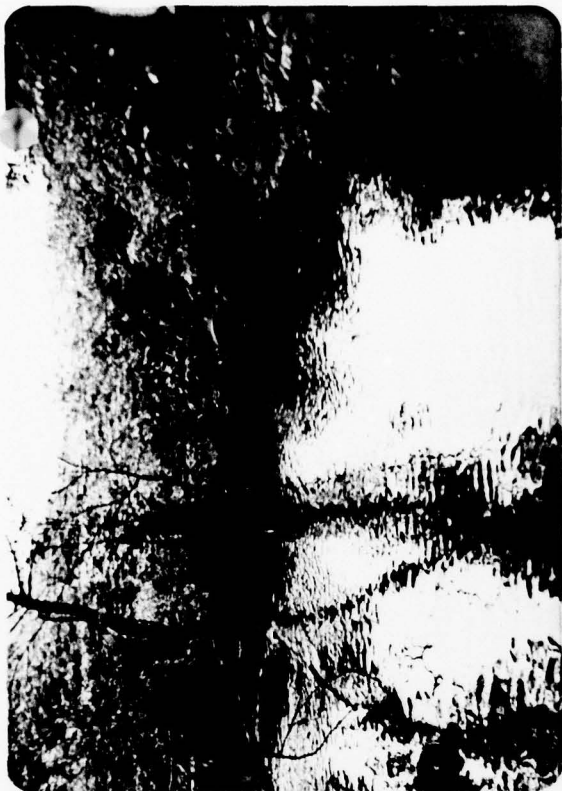
6

The discharge end of the cast iron blowoff line was found to be partially obstructed and not connected to the terra-cotta pipe extension (Photograph 5) which terminates in the stream about 120 feet from the downstream toe (see Photograph 6). The pump house structure was observed to be dilapidated and the apparent subject of extensive vandalism.

e. Downstream Channel. The channel downstream of Cherry Run Dam is contained within a gently sloped, broad, tree and brush filled valley. Normal flow is confined in a small meandering stream about 25 feet wide and 5 feet in depth. Four residential dwellings and a power plant are located along the stream within 1-1/2 miles of the dam. At least three of the residential dwellings are sufficiently close to the stream that they could suffer damage with possible loss of life from high flows associated with a dam failure (see Photograph 12). Thus, the hazard classification of the facility is considered to be "high".
